Limited Asbestos and Lead Survey Report

1995 Market St.

**Project Number:** 5536

May 8, 2023

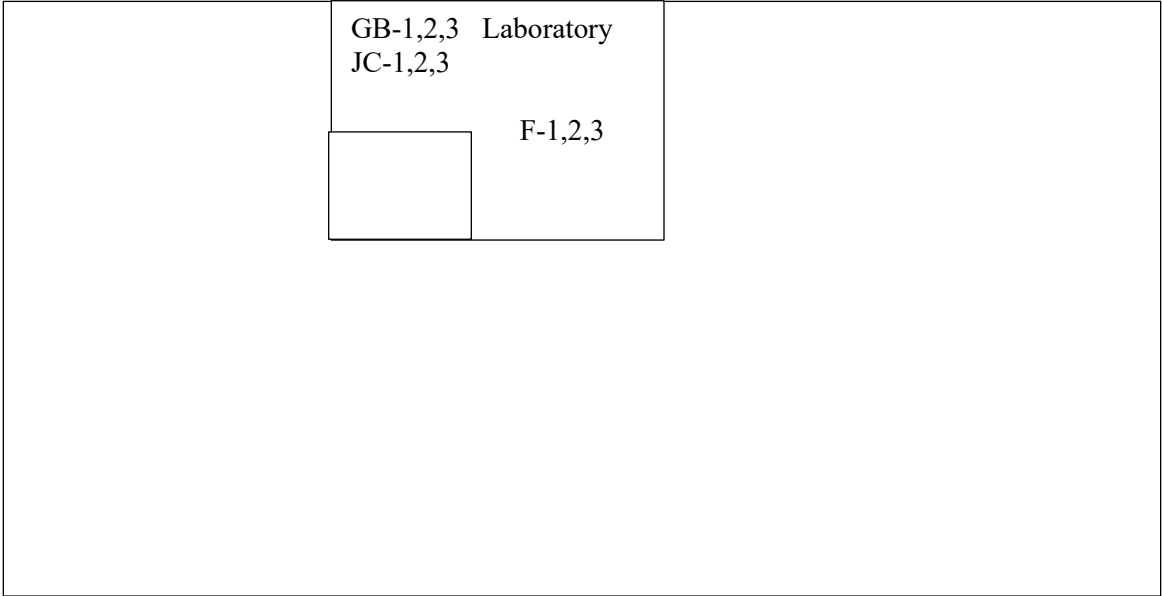
Sketch not to scale.  
Sample ID indicates location of sampling.

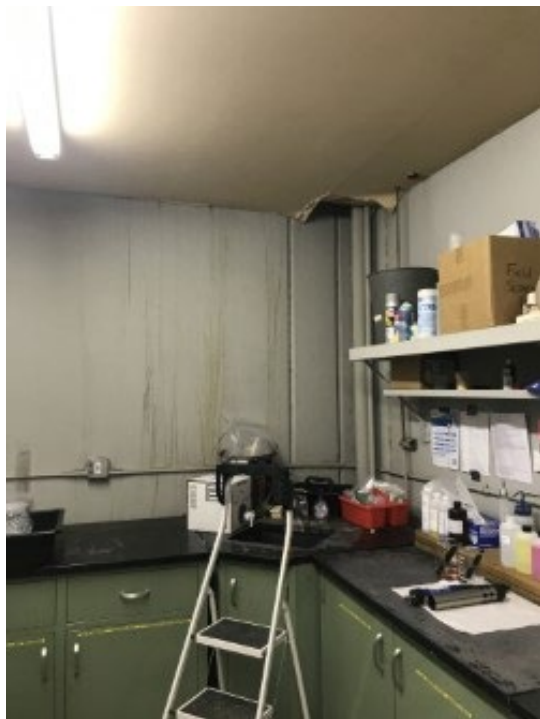
Based on the field assessment and XRF analysis, Lead-Based paint was not detected on the materials sampled.

Picture 1: Work area of the WPD laboratory. Lead-based paint was not detected via XRF

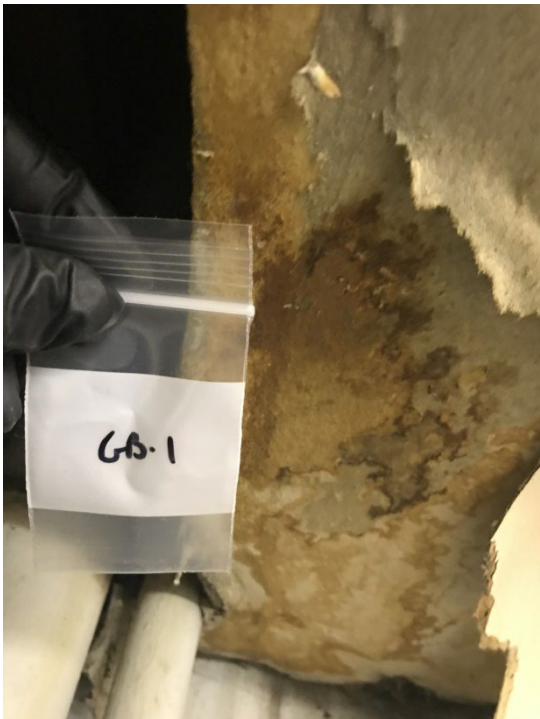
Picture 2: Ceiling gypsum board sampled was found to not contain asbestos

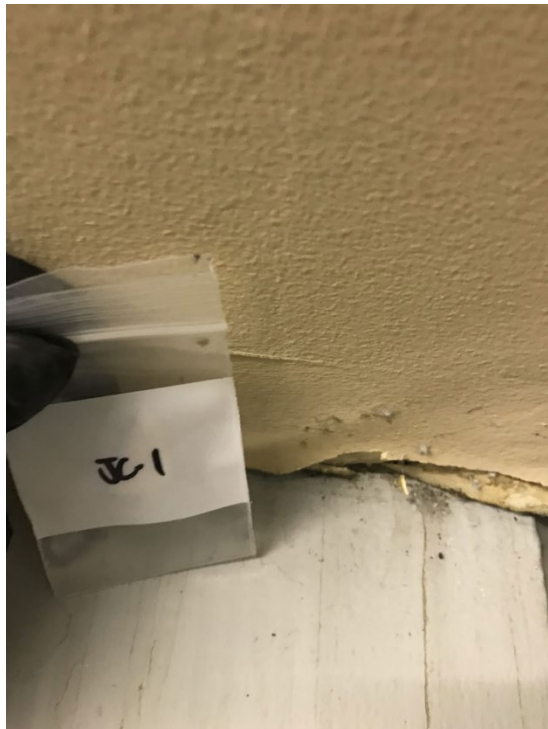
\*The ceiling joint compound sampled was found to contain <1% asbestos and can be point counted. Due to the ceiling joint compound containing asbestos, I, Andrea Pulsipher CAC No. 17-5929, assume the ceiling joint compound is ACM subject to Rule 1403.

Picture 3: Ceiling joint compound was determined to be ACM by CAC

**Abatement by a licensed abatement contractor is required prior to disturbance of asbestos containing materials.**

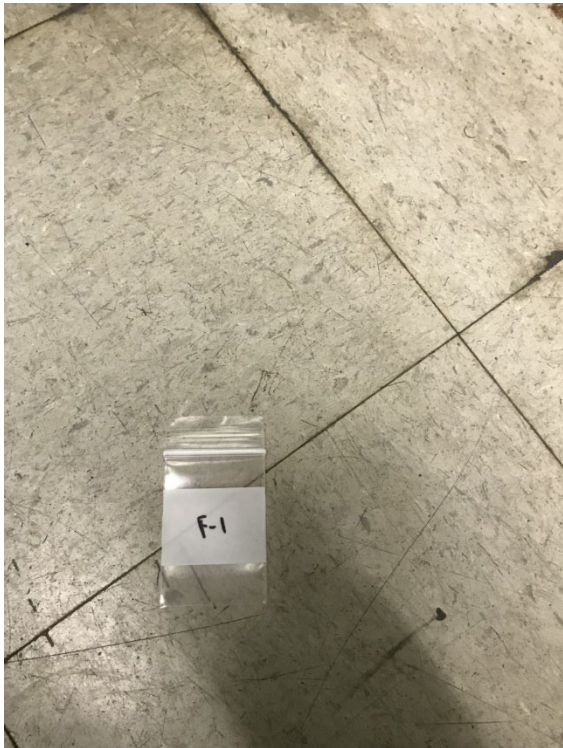
- **Ceiling joint compound\***
- **Black/Tan mastic associated with 12x12 beige floor tile**

Picture 4: Black/Tan mastic layer associated with 12x12 beige floor tile sampled was found to contain asbestos
